**Checklist for Phase I Site Assessments Conducted using EPA Brownfields
Assessment Grant Funds**

Name / Address of Property Assessed: 609 May Street and 800 N. Larch Street

Triterra completed a Phase I Environmental Site Assessment (ESA) for the parcels of property located at 609 May Street and 800 N. Larch Street, in Lansing, Michigan (the Property). The Phase I ESA was requested by Mr. Ryan Ruehle of Ryan's Auto Care 1 to establish the environmental conditions of the Property prior to purchasing the Property.

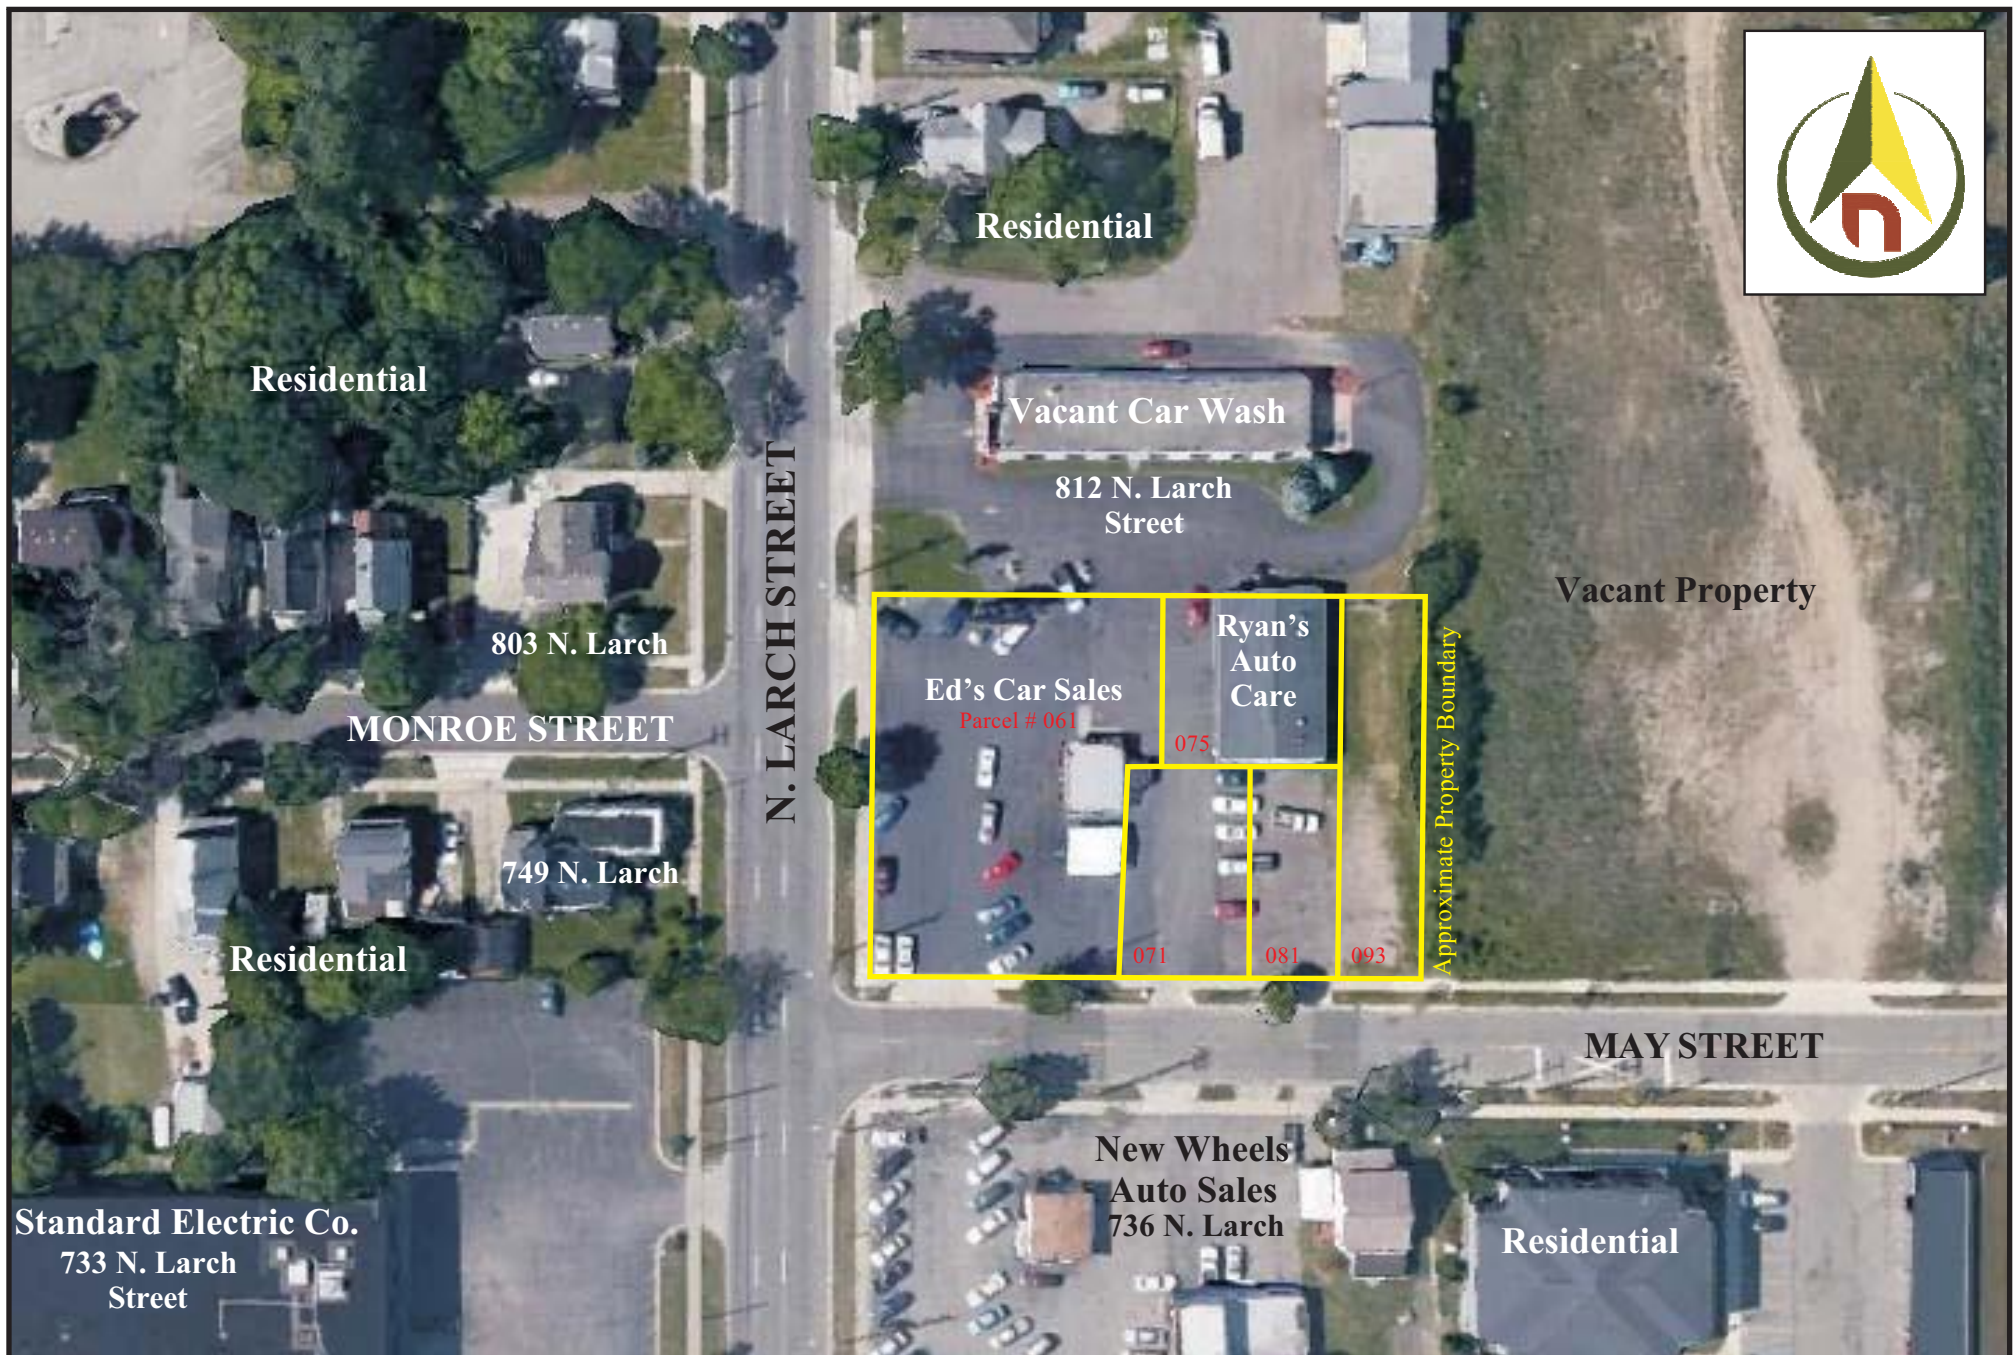
FIGURE 2

Property layout and boundaries are depicted on the Property Orientation Diagram (Figure 2).

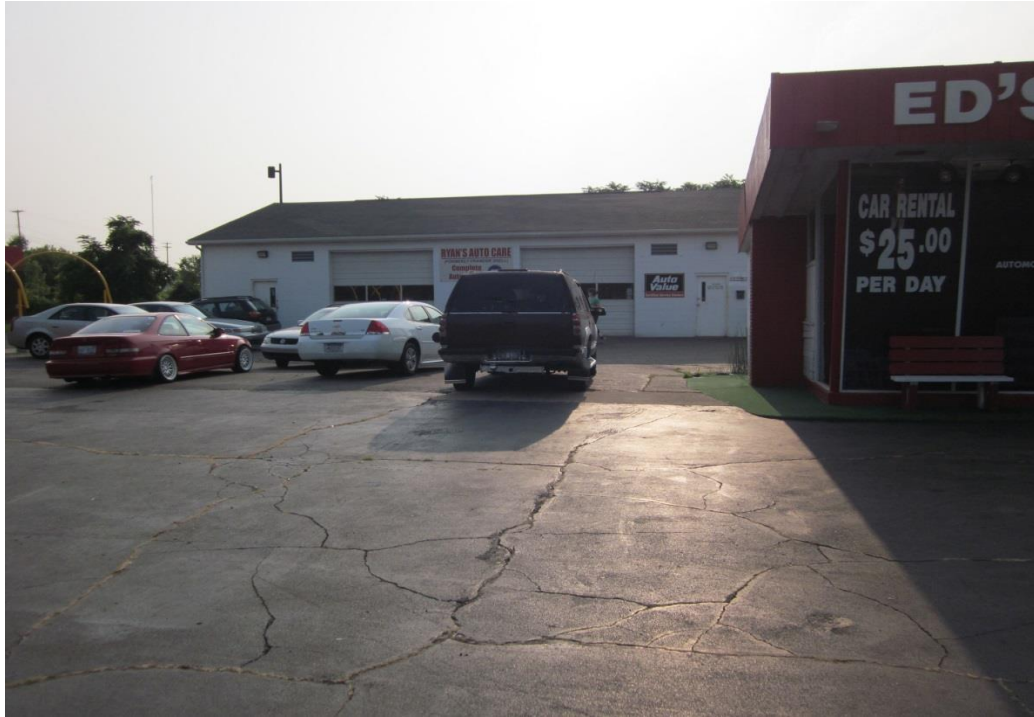
PHOTO: 1 **DATE: 8/1/2014** **BY: A. Tiernan**
SUBJECT: View of the commercial Property, located at 800 N. Larch Street and 609 May Street in Lansing, Michigan.

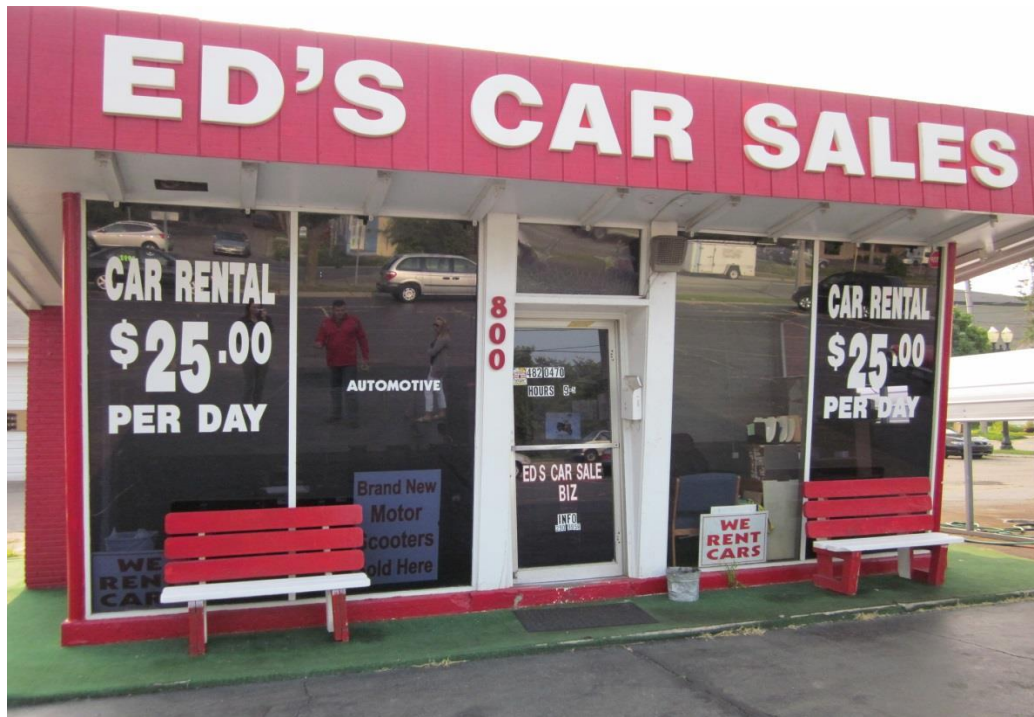
PHOTO: 2 **DATE: 8/1/2014** **BY: A. Tiernan**
SUBJECT: View of the 800 N. Larch Street building, used as an office and storage for the used car sales operation.

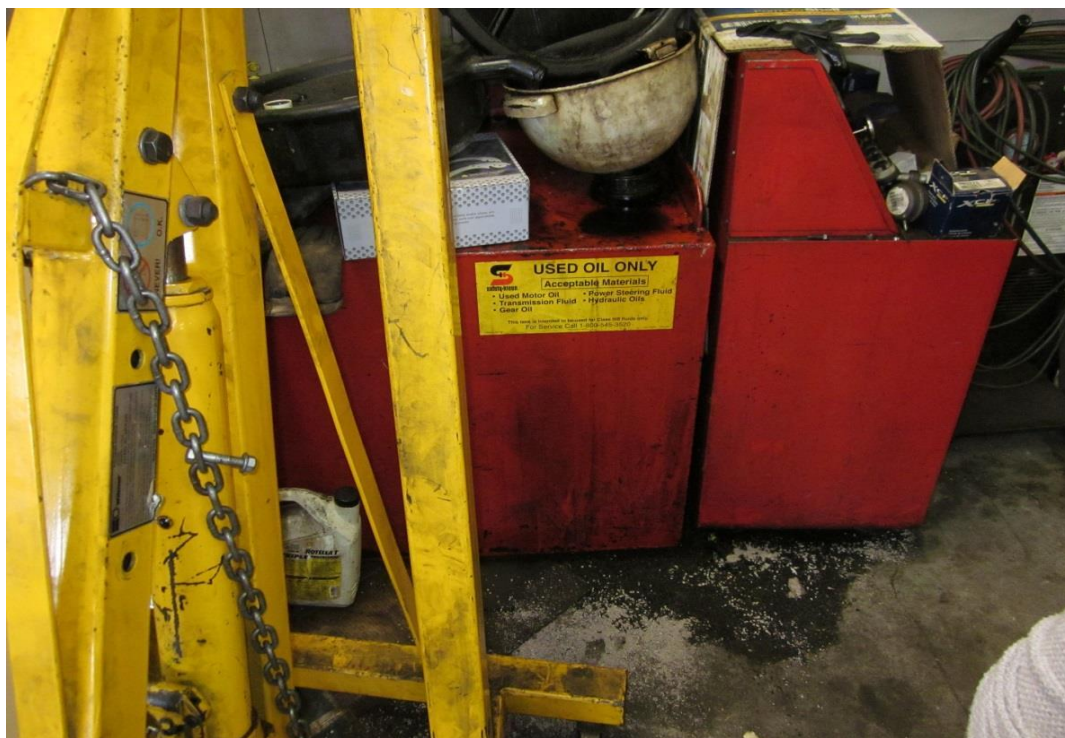
Triterra observed a 250-gallon waste oil AST located in the north bay of the service garage. The AST appeared to be in good condition, and any staining around the AST appeared to be contained with a quick-dry substance. In Triterra's opinion, the potential for contamination from use of the 250-gallon waste oil AST represents a suspect REC in connection with the Property.

PHOTO: 5 **DATE: 8/1/2014** **BY: A. Tiernan**
SUBJECT: Waste oil was collected in a 250-gallon AST located in the north bay of the garage. Some staining was observed around the AST.

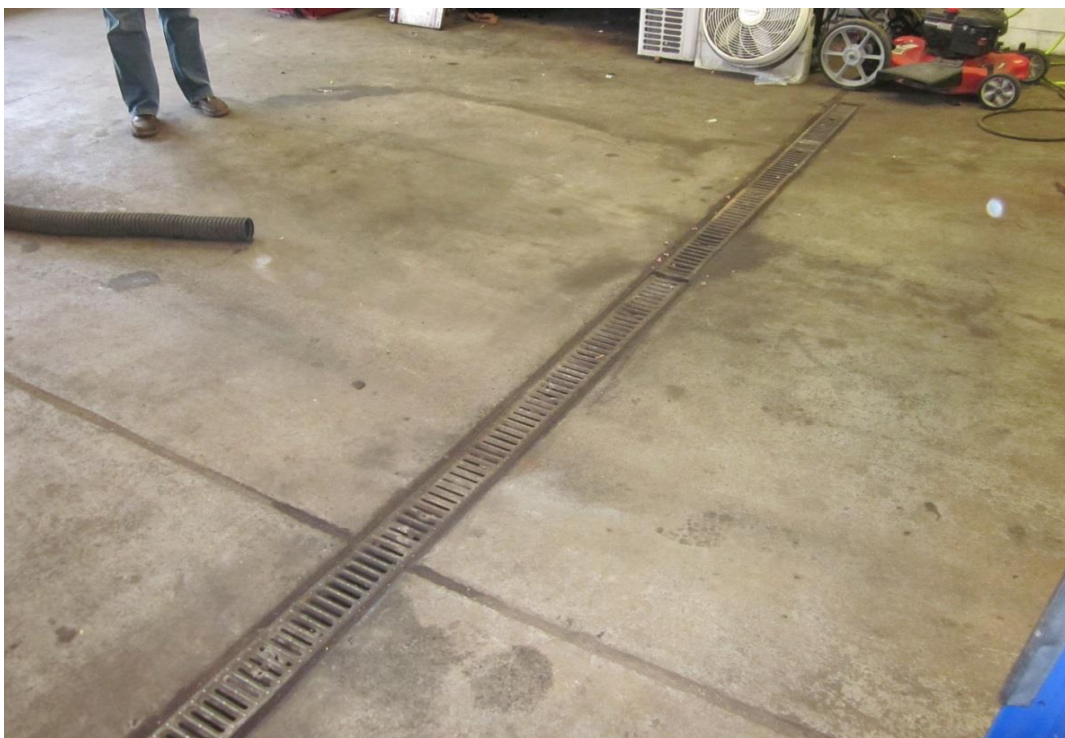
Trench drains were observed in the auto repair garage spanning the width of both bays. The drains reportedly discharge into the municipal sewer system. No unusual stains were observed around the drains and they appeared

to be in good condition. However, small cracks in the concrete floor were observed in a few areas throughout the garages. In Triterra's opinion, the trench drain and cracks in the concrete represent potential pathways for the hazardous substances and petroleum products to be released into the ground surface or subsurface.

PHOTO: 6 **DATE: 8/1/2014** **BY: A. Tiernan**
SUBJECT: Trench drains spanned the length of both garage bays. The floors gently sloped to the center of the garage.

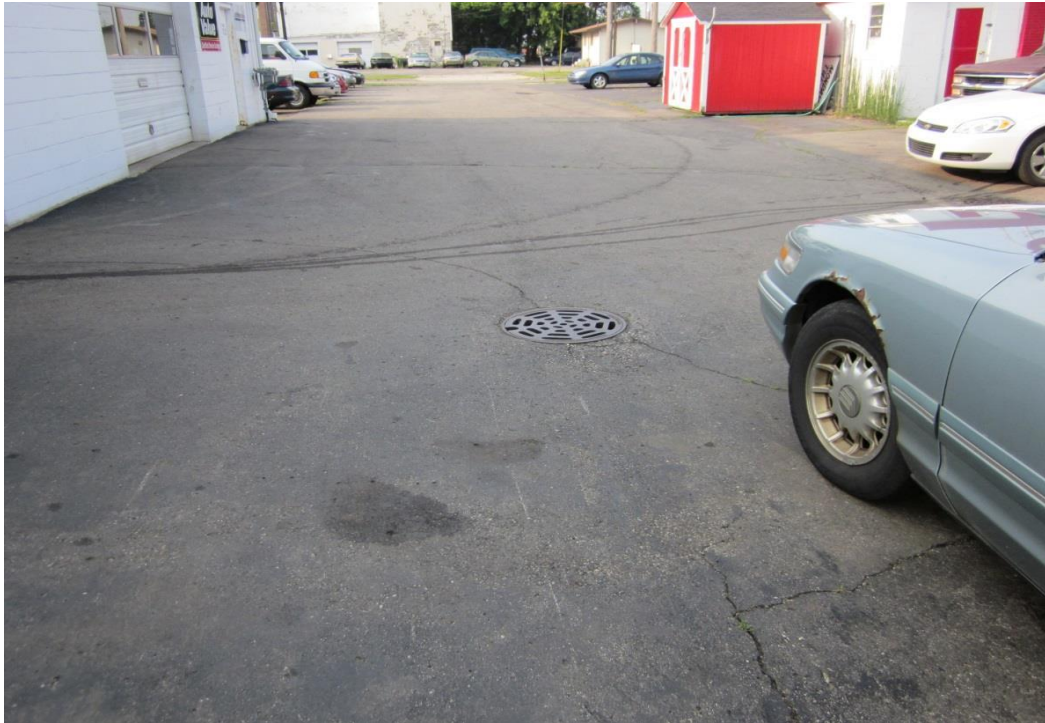
PHOTO: 7 **DATE: 8/1/2014** **BY: A. Tiernan**
SUBJECT: **View of the asphalt between the repair garage and sales office. Some cracking in the asphalt was observed.**

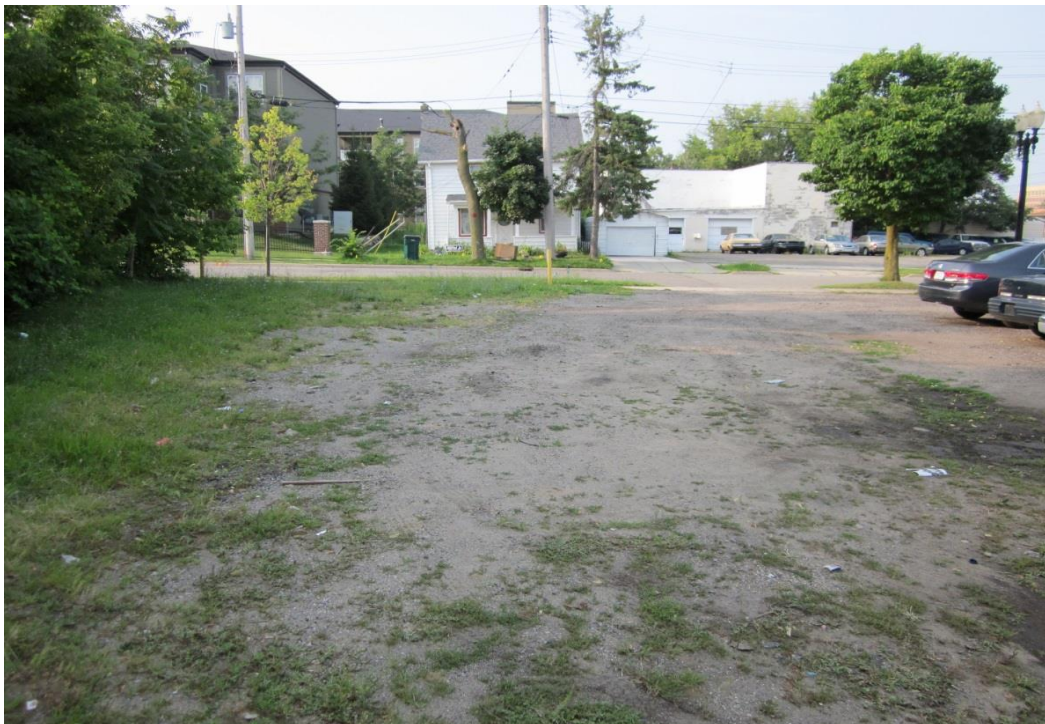
- **The potential for environmental impact associated with the material used to fill the foundations of the six houses formerly occupying the Property (Section 5.1).** Several buildings were present at the Property prior to the existing structures. Based on Triterra's experience, urban fill materials may contain metals and polynuclear aromatic hydrocarbons (PAHs) at concentrations above Part 201 generic residential cleanup criteria. Therefore, the presence of unknown fill materials on the northeast portion of the Property represents a REC in connection with the Property.

PHOTO: 8 **DATE: 8/1/2014** **BY: A. Tiernan**
SUBJECT: **View of the eastern parcel, formerly 617 May Street, facing south. The area without grass marks the location of a former residential dwelling.**

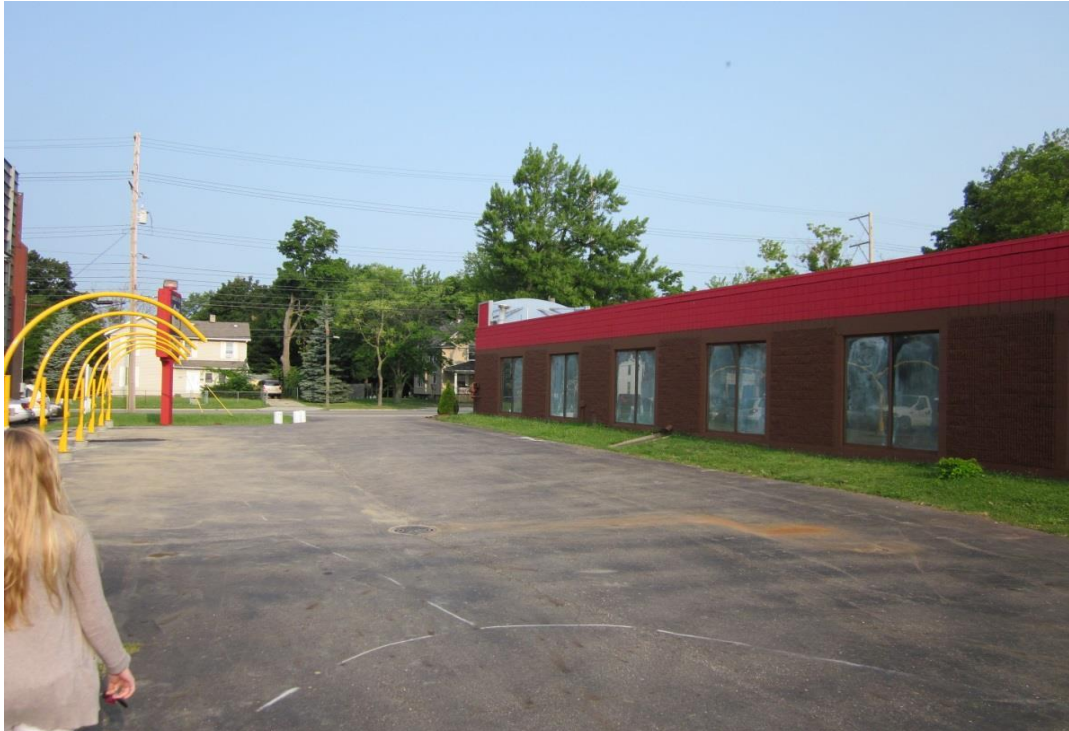
PHOTO: 9 **DATE: 8/1/2014** **BY: A. Tiernan**
SUBJECT: The north adjoining site previously operated as a car wash. The site was vacant at the time of the assessment.

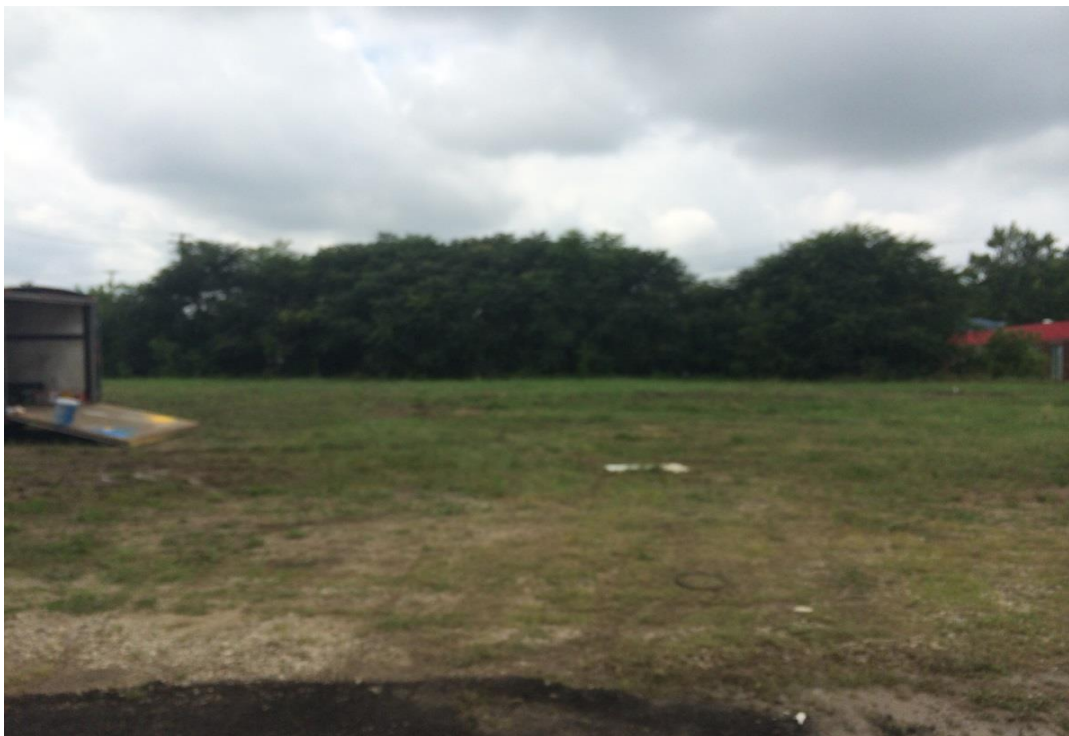
PHOTO: 10 **DATE: 8/1/2014** **BY: A. Tiernan**
SUBJECT: A vacant field adjoins the Property to the east, separated by a row of vegetation.

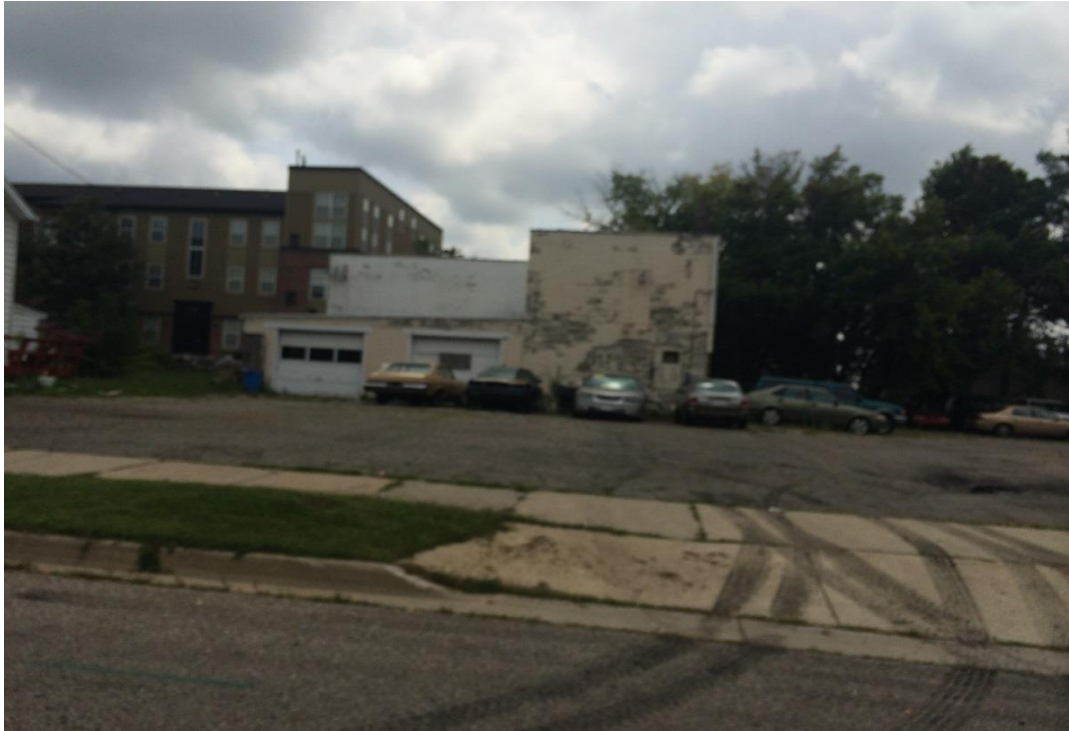
PHOTO: 11 **DATE:** 8/1/2014 **BY:** A. Tiernan
SUBJECT: The south adjoining site, 736 N. Larch Street, was occupied by a used auto dealer, New Wheels Auto Sales.

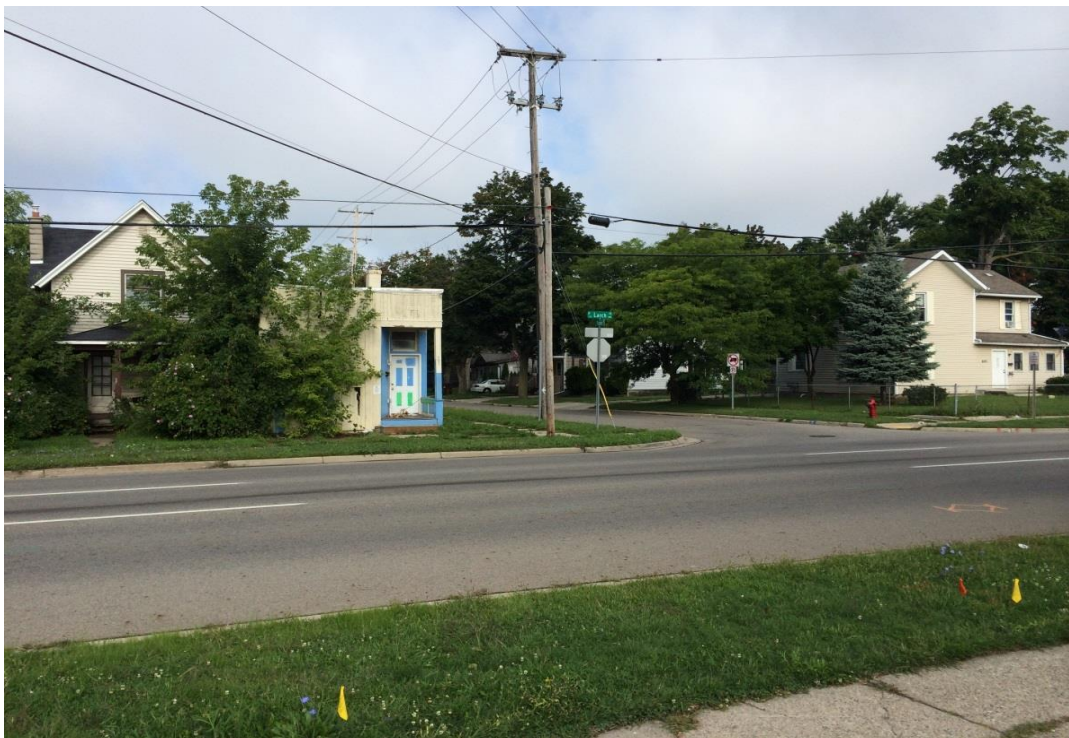
PHOTO: 12 **DATE:** 8/1/2014 **BY:** A. Tiernan
SUBJECT: Two residential dwellings adjoin the Property to the west, across N. Larch Street.

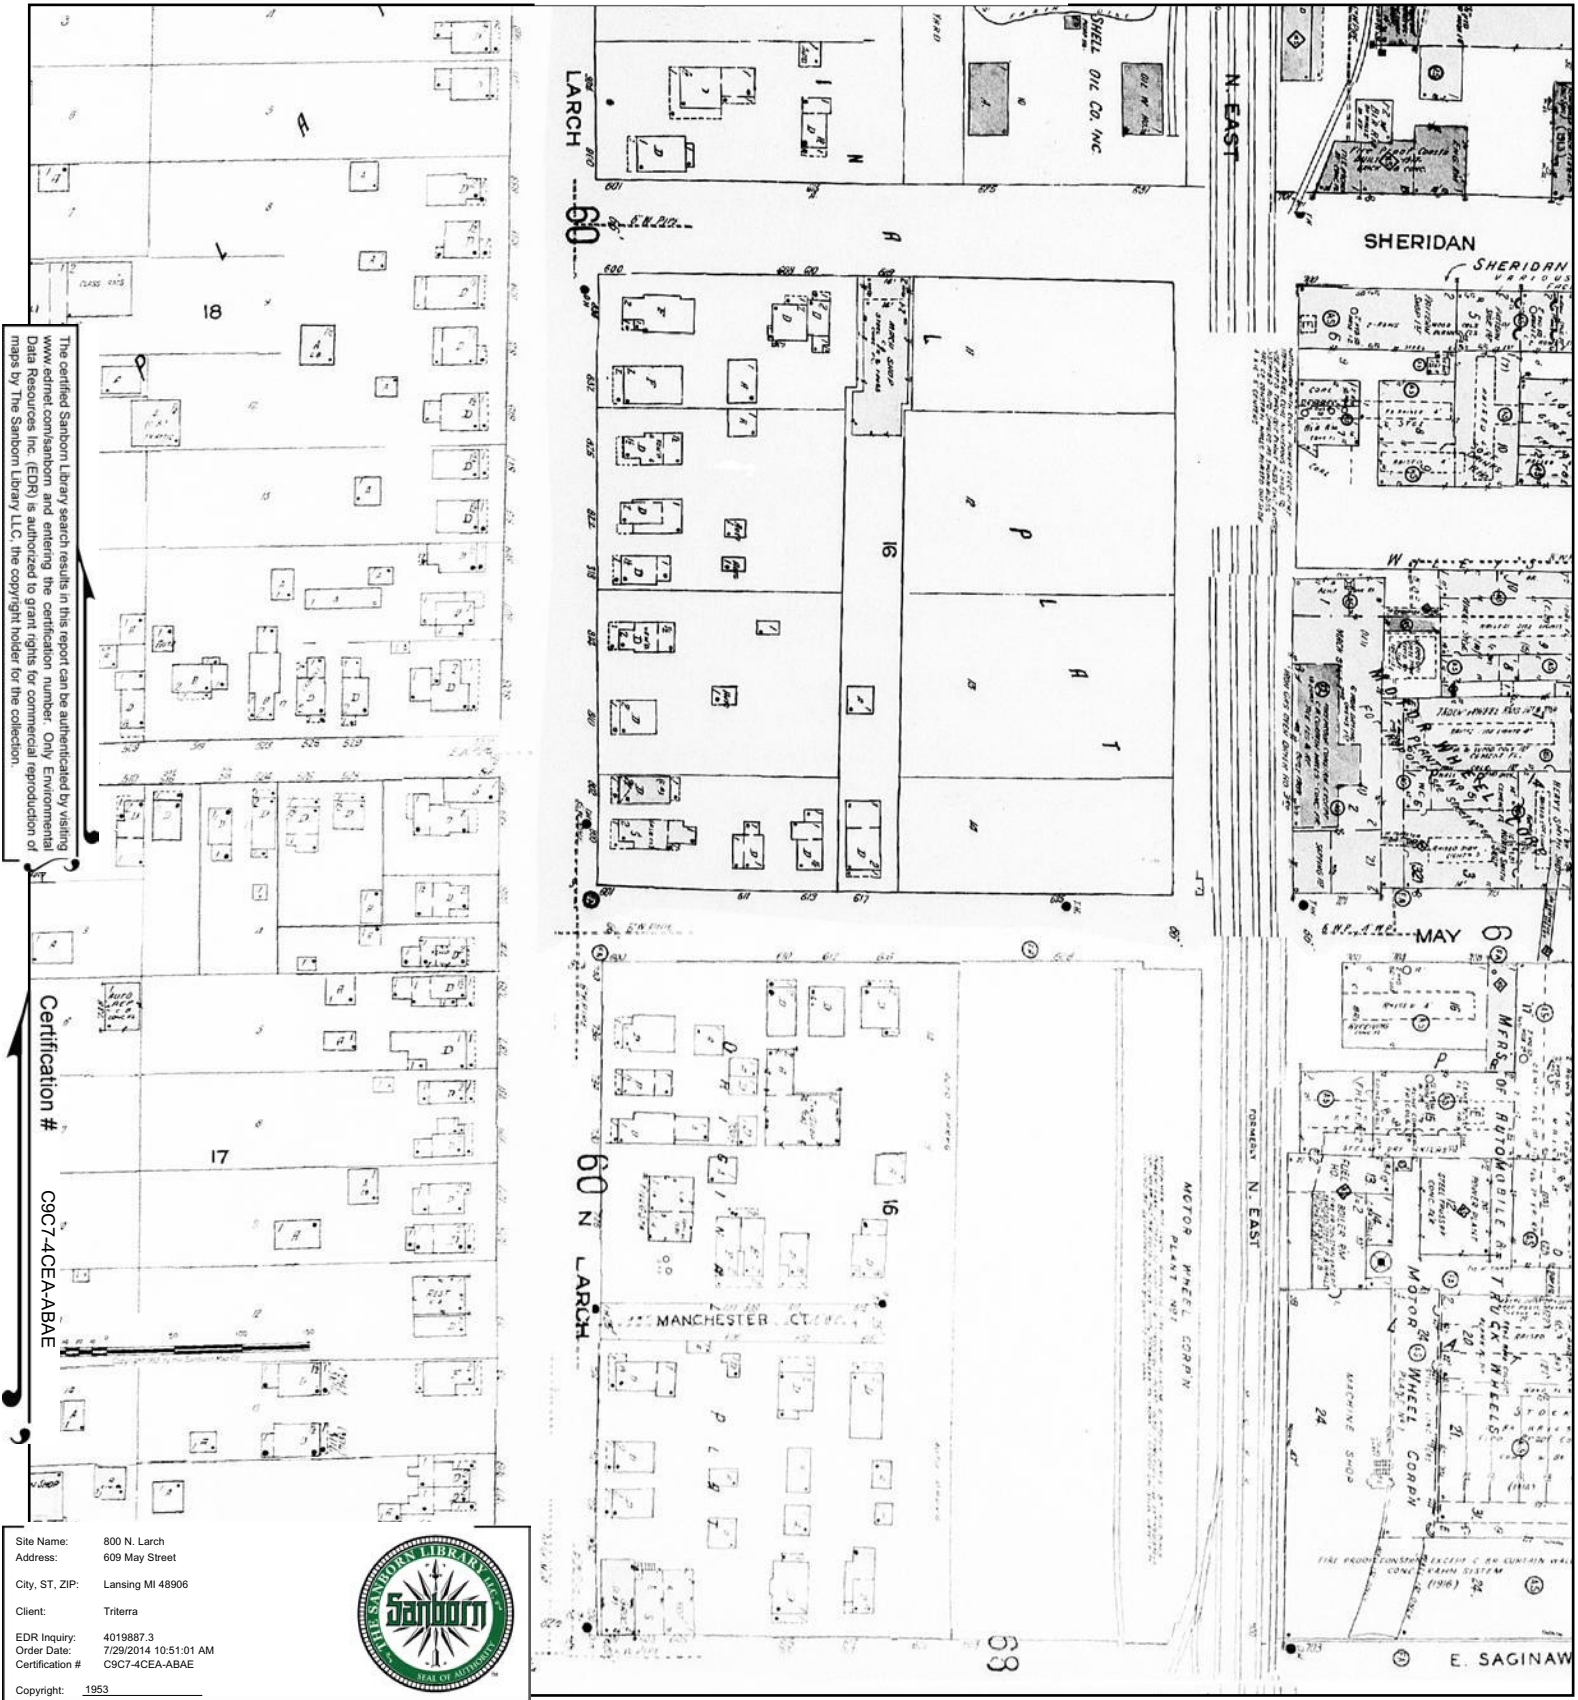
1953 Certified Sanborn Map

This Certified Sanborn Map combines the following sheets.
 Outlined areas indicate map sheets within the collection.
